Courthouse Commons Tunnel: A Case Study of Modern SEM Tunneling

ABSTRACT: The Courthouse Commons SEM Tunnel was excavated within 6 feet of cover beneath two buildings in downtown San Diego utilizing high-precision geotechnical instrumentation. The excavated dimensions are approximately 25 feet in diameter and 328 feet in length connecting two in-service detention-level security buildings. Presupport includes large-diameter grouted canopy pipes and smaller pipe spiles. Initial support consists of fiber-reinforced shotcrete with lattice girders. This paper presents observed ground and structure behavior and lessons learned. During construction an unanticipated brick structure was encountered, and methods were developed to improve adhesion of shotcrete to sandy soil and to reduce rebound.

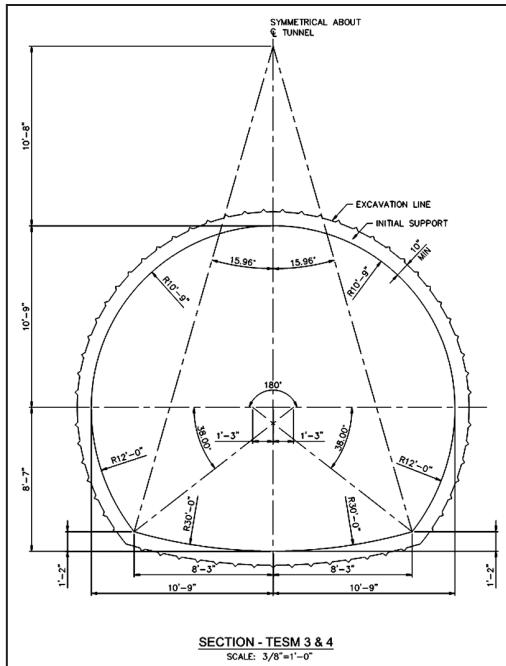
Figure 1. Excavated cross-sectional geometry of TESMs 3 and 4

The CoCo Tunnel was designed with four discrete zones of tunnel excavation and initial support measures (TESMs) across the 328-foot length and consists of three different excavated cross sections based on anticipated ground conditions and ground support type. The largest of the TESM cross sections was excavated to allow for placement of crushable backfill and joints in the final lining to accommodate movement in the event of fault rupture where the alignment passes through the San Diego Fault. The tunnel cross section throughout the entire alignment generally takes the shape of a modified horseshoe with curved invert. From east to west, the cross-sectional diameter at springline measures 25'10" at TESMs 1 and 2, and 21'6" at TESMs 3 and 4. The typical excavated cross section for TESMs 3 and 4, which made up the western 254 feet of the tunnel, is shown in Figure 1. The difference between these two

TESMs is the type of presupport utilized—canopy pipes for TESM 3 and pipe spiles for TESM 4.

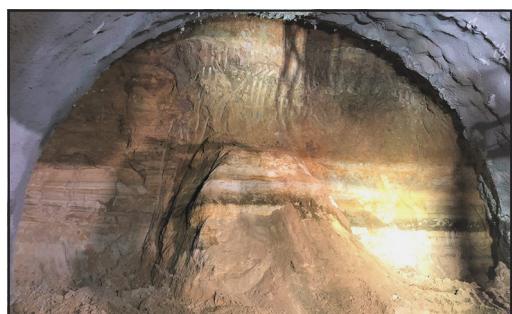
Figure 2. Typical excavated top heading prior to flashcrete with face wedge in place

A final element used for ground support during excavation was the face wedge, used to provide stability to the face of the advance. The face wedge always stood a minimum of 8 feet tall with 6 feet of clear space on each side relative to the excavated sidewall. The wedge was approximately 2 feet deep before sloping down to the invert at 45° to 60° . These dimensions allowed for a mass of soil to act as a gravity wall in front of the excavated face, but also provided adequate clear access for shotcrete installation. Figure 2 shows a typical excavated top heading with face wedge in place prior to application of shotcrete.

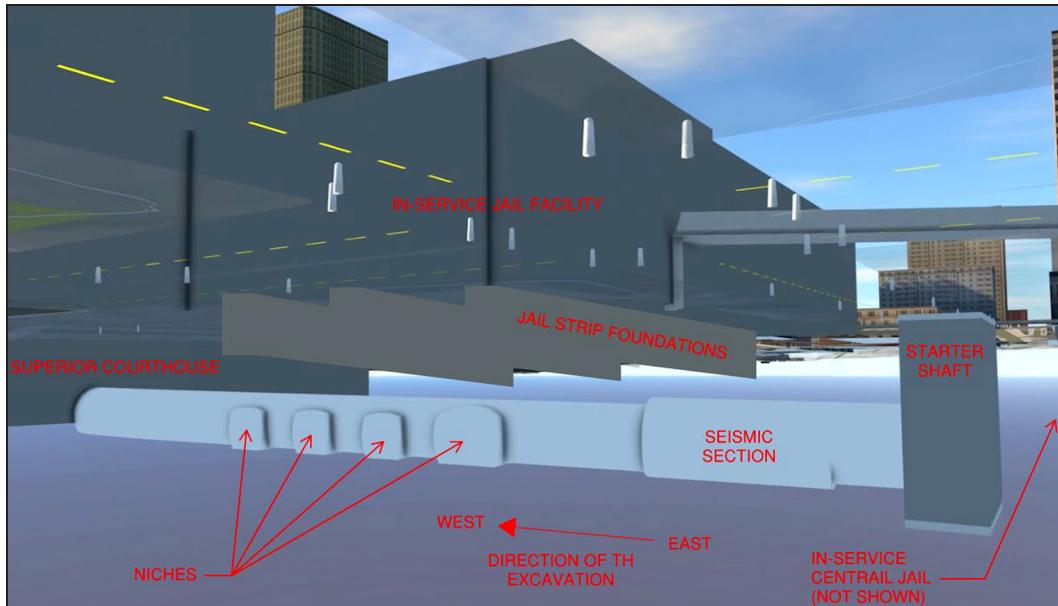
Figure 3. Three-dimensional schematic of tunnel alignment from starter shaft to superior courthouse

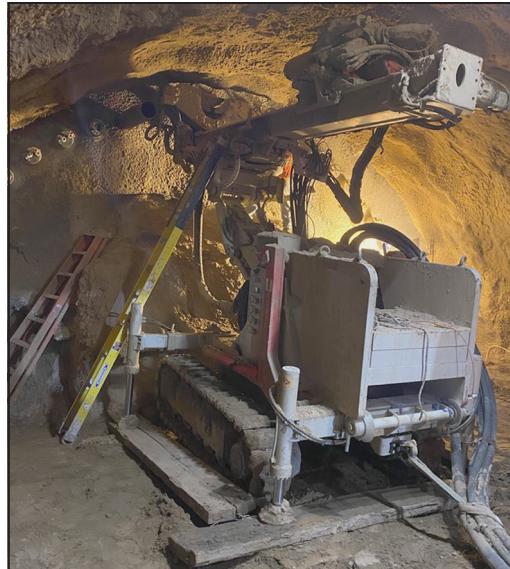
Figure 4. Setup of canopy pipe installation drill rig at STA 00+77

The canopy pipes were installed in 5-foot segments as an outer casing using a hydraulic, rotary-percussive drill rig with a fully articulating mast and directional drilling capability. The leading 5-foot pipe casing had carbide tip teeth welded flush to cut through the soil during installation with no more than a $\frac{1}{8}$ -inch overcut. An inner drill rod was used with a drag bit that led the pipe casing by 6 inches to guide the drilling and serve as a conduit for air and water to flush spoils out between the inner rod and outer casing. After the full length of canopy pipe installation

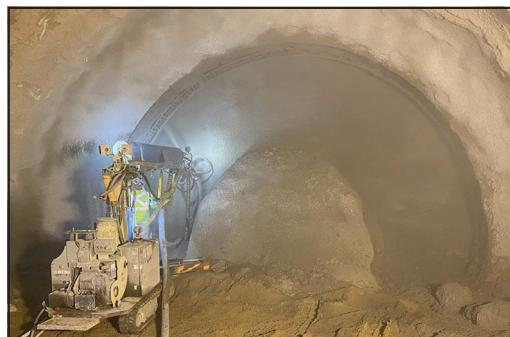
Figure 5. Placement of shotcrete initial lining after lattice girder installation

With the flashcrete and lattice girder in place for a given advance, the final step for initial support was to encase the lattice girder and fill the excavated bay to full thickness (shotcrete by use of the shotcrete robot, which is shown in Figure 5). Despite the thickness of shotcrete to be applied in this stage being greater than the flashcrete, the initial lining could be placed relatively quickly since it was sprayed on hardened shotcrete as opposed to looser sands and gravels, resulting in significantly less rebound. The robot was fed by a 3-inch-diameter slickline that ran

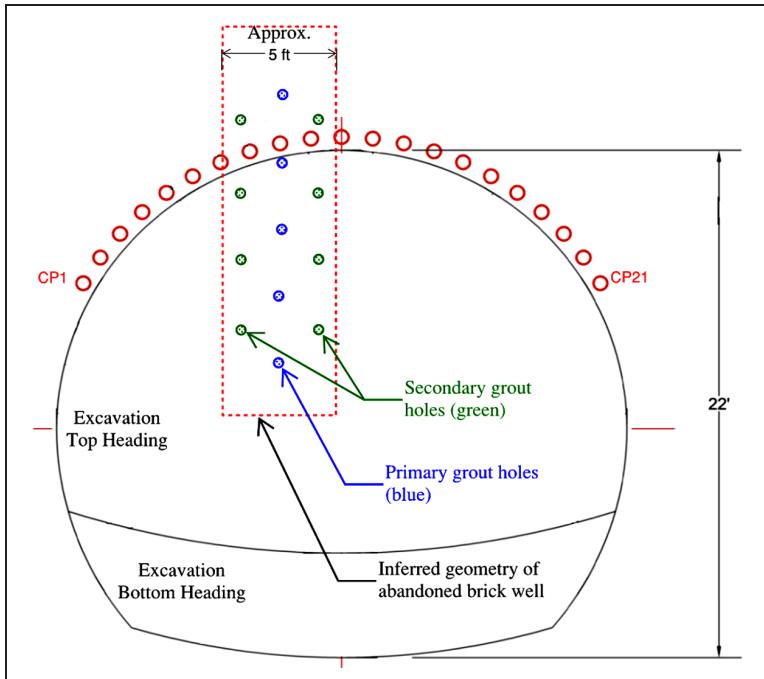
Figure 6. Simplified layout of abandoned brick well grouting campaign with canopy pipe (CP) layout included

Five primary grouting holes were established along the centerline of the vertical brick well structure from top to bottom at approximately 2- to 3-foot intervals as shown in Figure 6. The PVC casings were grouted using a ball valve and grout port and an ordinary Portland cement, lean grout mix of 1:1 by weight. All five primary holes were set up with valves in the open position and grouting was performed starting at the lowermost hole. Working from the bottom up allowed for grout to be pumped until return was observed at the next highest hole, at which point the current valve through which grout was being injected was shut off and the operation would begin grouting through the next highest hole. In the first day of grouting these five primary holes,

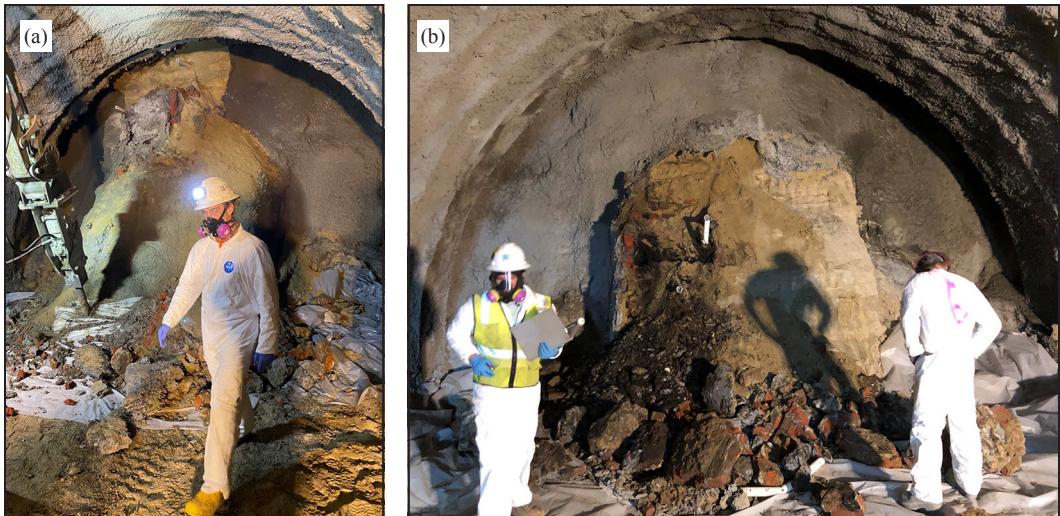
Figure 7. Brick structure excavation during removal of (a) upper portion and (b) lower portion

within the brick structure would need to be segregated for disposal and additional personal protective equipment was required of all personnel when handling the material or within the tunnel during excavation. Once the expected advance in which the brick well structure would be encountered was reached, excavation proceeded with removal of ground at the face and face wedge around the well that could be mucked out as usual. Flashcrete was then applied on all portions of open ground surrounding the then exposed brick well, and plastic sheeting was set to contain any contaminated material. This process was required for two separate rounds of excavation, one where the brick well was excavated from the upper portion of the advancing face, and a second when the abandoned brick well was excavated out of the face wedge as shown in Figure 7.

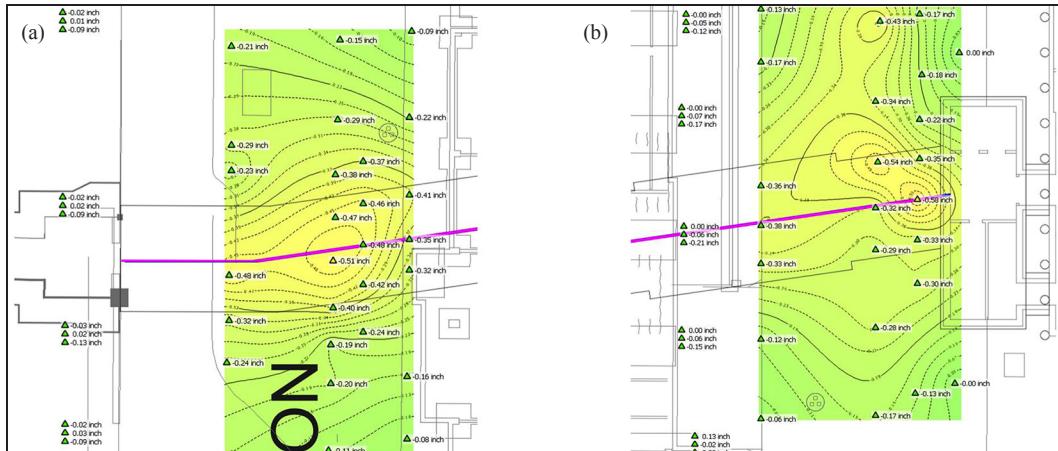
Figure 8. Settlement gradation view at (a) Union Street and (b) Front Street taken on 10/31/2021

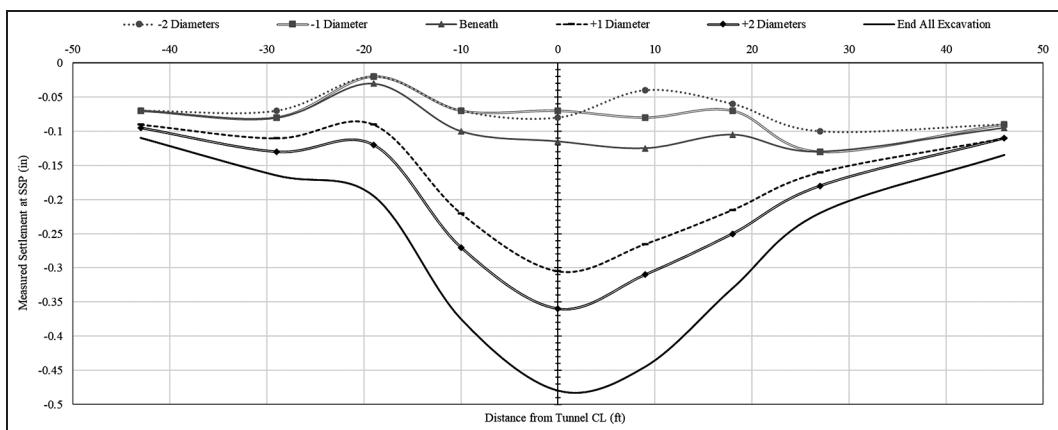
Figure 9. Settlement troughs measured along the center of Union Street during top heading excavation

Six different settlement troughs corresponding to the array of prisms set in a north-south trending direction down the center of Union Street are shown in Figure 9. The six plotted lines show increasing settlement and formation of a parabolic settlement trough when viewed in the following order:

1. Excavated top heading face 2 diameters before the SSP array

2. Excavated top heading face 1 diameter before the SSP array
3. Excavated top heading face directly beneath the SSP array
4. Excavated top heading face 1 diameter past the SSP array
5. Excavated top heading face 2 diameters past the SSP array
6. All tunnel and niche excavation and initial support complete

Also noteworthy is the -0.48 inch of settlement that occurred at the center point of this array by the time all excavation on the project was completed, and the -0.19 inch (40%) that occurred during the period where the excavation top heading face ranged from directly beneath the array to 1 diameter distance past.

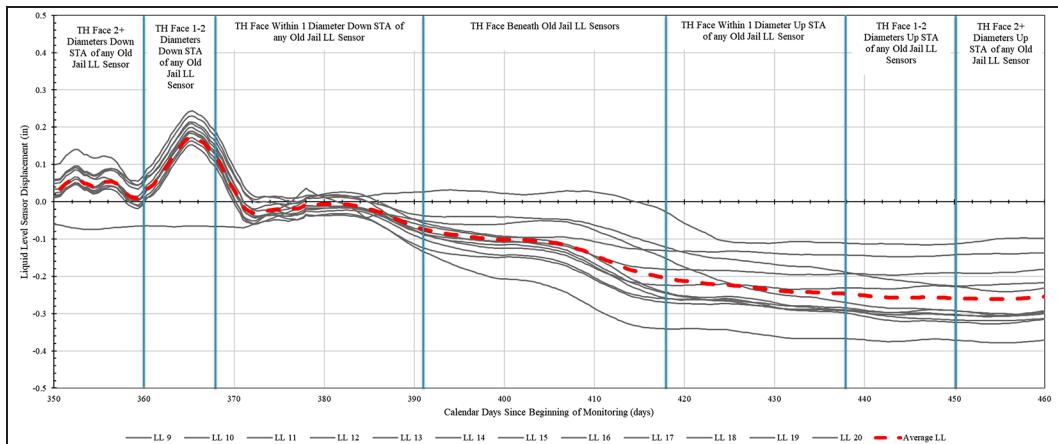
Figure 10. Liquid level sensor output within the Old Jail from 10/03/20 (at 350 days) to 01/21/21 (at 460 days)

While LL sensors provided unreliable data at many times throughout the project and necessitated maintenance at unpredictable intervals, they typically provided reasonable approximations of building settlement when manual surveys were not performed within the basements. Figure 10 depicts a graph of all LL sensors on basement columns in the Old Jail from a period ranging from October 3, 2020 to January 21, 2021 (at 350 and at 460 days from the commencement of monitoring, respectively). The array of LL sensors in this building ranged from STA

00+87 to 01+35 along the tunnel alignment. Figure 9 is notated with the periods in which the top heading of the tunnel was mined beneath these sensors, and when the top heading face was within one or two tunnel diameters' distance from the sensors. The precise value outputs from the LL sensors in this case were too small relative to the accuracy of the system, but the general trend of most of the settlement occurring while mining beneath and beyond for one diameter's distance from the sensors can again be observed. The divergence of LL sensor values from one another during this period and throughout the future of the project also exemplifies the settlement trough formation as discussed earlier.
